FROM OLD TO NEW – A RESTORATION PROJECT

The Nazeing Church Sundial

IAN BUTSON

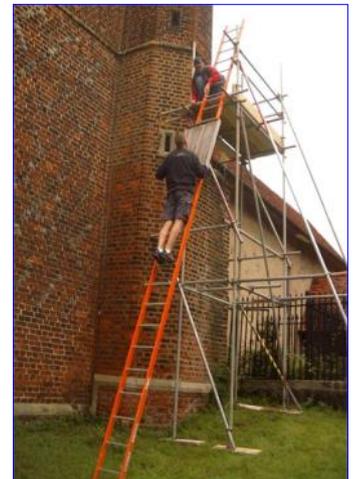
Fig. 3. Removing the old dial from the tower.

Before any work could commence, the old dial would need to be removed from the tower to inspect its condition and also for analysis of its unusual furniture. As the ground at the base of the tower slopes badly, the simple use of a ladder or even of a ‘cherry-picker’ type of hoist to reach the dial was thought unsuitable, but that scaffolding would be required to remove the dial in safety. In August 2009, scaffolding was erected and the dial was removed by Bryn Pateman, a friend of the benefactor (Fig. 3).

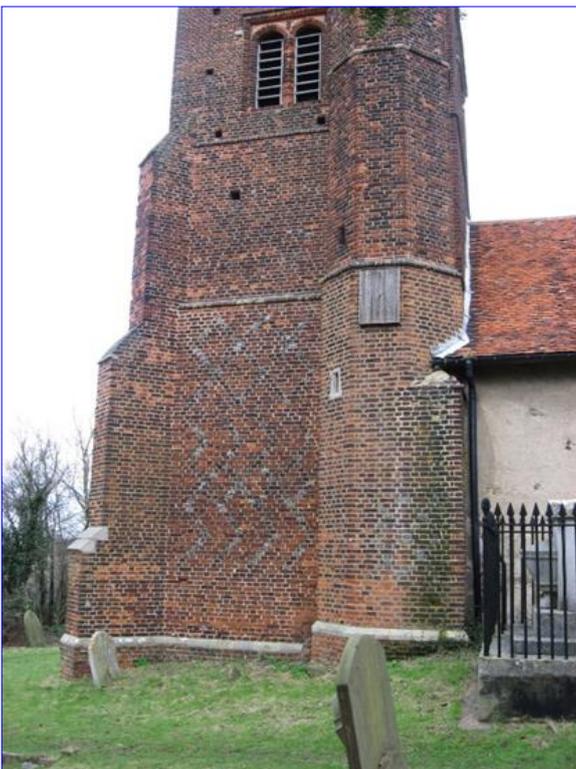
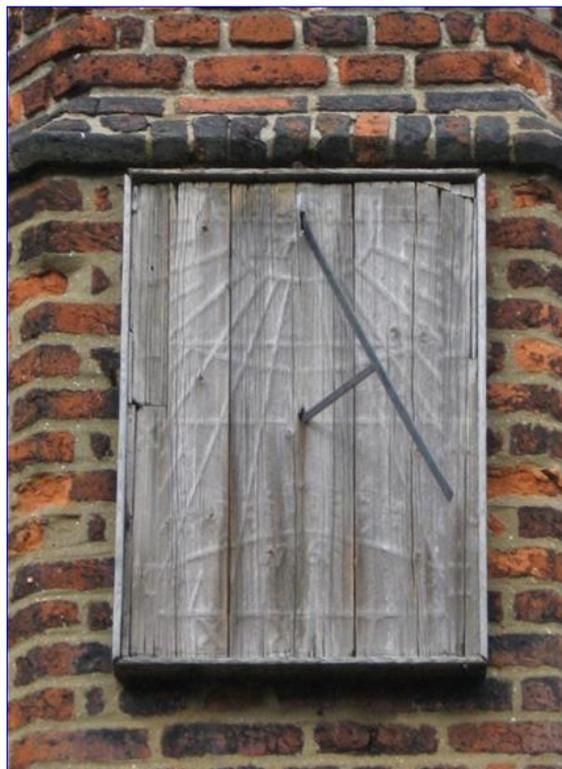
Figs 1 & 2. The unrestored dial on the tower of Nazeing Church.

The church of All Saints, Nazeing is located to the south-west of Harlow, standing high on an exposed and windy ridge on the east side of the Lea Valley in Essex. As well as having a mass dial on the nave of the church, complete with an old iron gnomon, the tower of the church also has a large carved wooden sundial. This vertical dial is of some interest, but had become very badly worn over time, so restoration was suggested. It is mounted high up on the south face of the staircase to the bell chamber at the south-east corner of the tower, as shown in Fig. 1. Over the years, the surface of the dial had become worn and also the gnomon mounting holes had allowed the gnomon to become loose and to be blown sideways by the prevailing wind in this exposed location.

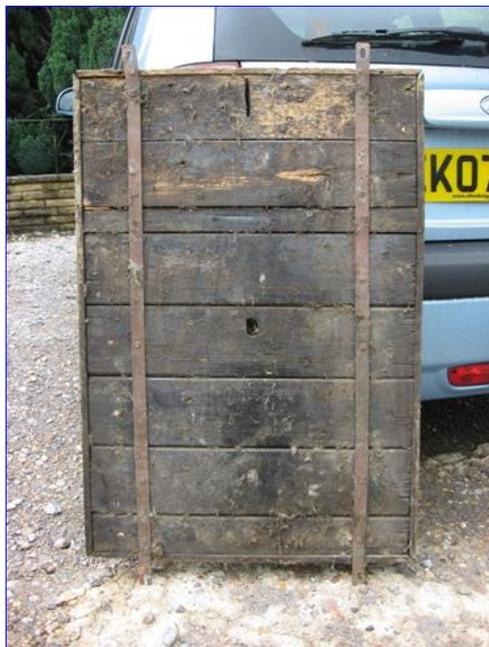
Fig. 4. The construction of the back of the old dial.

On inspection, the dial was found to have been constructed of three pine boards, approximately 1" thick and carved in relief. Upon later inspection by experts, it was considered that the wood, as indicated by the date of 1765 shown on the dial, was almost certainly that of the original, but had undergone a number of repairs in the past. The carved woodwork of the dial had been mounted onto a support backing of tongue-and-groove boards, possibly typical of stock material used for railway carriage woodwork of the late 1800s or early 1900s period. The gnomon was in generally sound condition, but only just resting in the dial woodwork and also without its retaining pins to the rear of the body of the dial, thus allowing it to move loosely on the face of the dial.

On closer inspection and due to the overall poor condition of the dial, it was felt that a completely new dial would be the most appropriate choice in the restoration process.

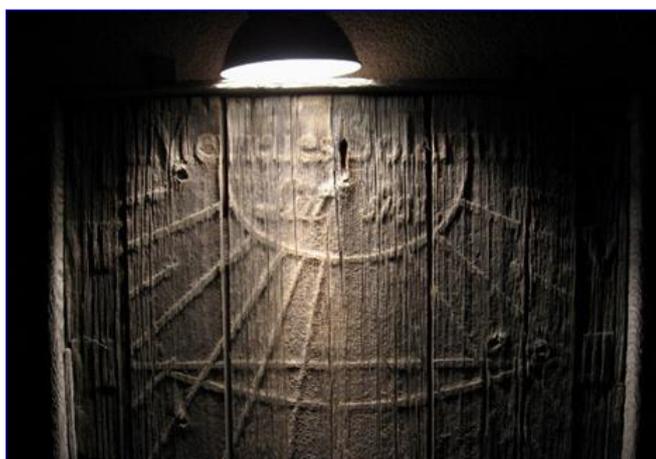
Fig. 5. Glancing illumination to highlight the carving.

Although some features of the markings on the dial could be identified with some certainty, it was not possible to fully identify them all. Side-lighting of the dial by means of an 'anglepoise' lamp proved to be particularly successful, especially so in a darkened room, as shown in Fig. 5.

Close inspection of the furniture fully confirmed the motto as "*Meridies Solarium*", the latitude details, declination lines for the equinoxes and solstices and the date of 1765.

A series of vertical lines, with adjacent lettering carved across the lower area of the dial, previously unidentified, proved to be solar azimuth lines with eight directions noted, from SE through South to SW being indicated.

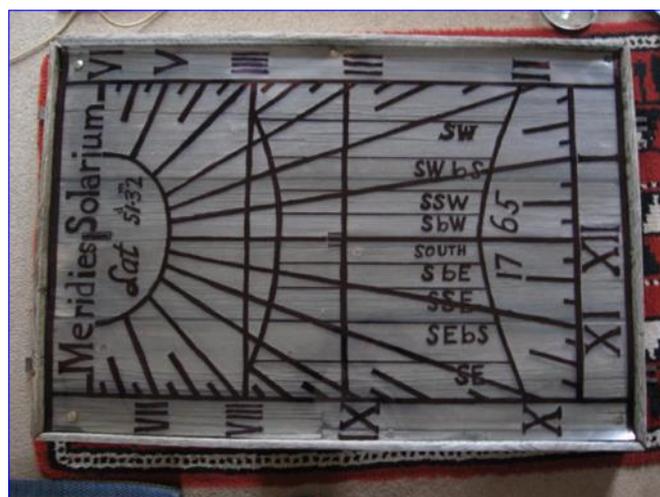
A sheet of clear plastic ('Melinex', an ICI product) was fitted over the dial and the original furniture markings traced out with a marker pen to produce a better picture and gain a greater impression of the original markings on the dial plate (Fig. 6).

Fig. 6. The carving transferred onto a Melinex sheet.

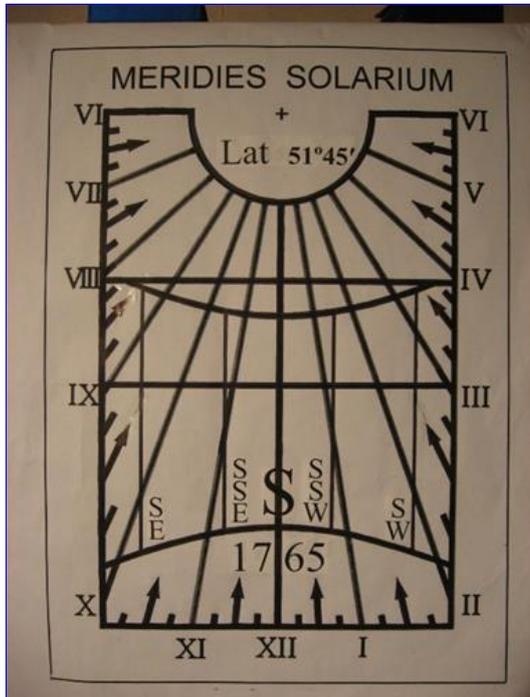
Full-size plans were produced with the aid of a PC-Sundial design program showing a possible new layout, but only including the four major azimuth lines and lettering to reduce overcrowding, but also to maintain elements of the original dial features incorporated into the new design. With all the other features to be retained from the original dial, a final design layout was decided upon.

Fig. 7. Drawing for the new dial.

The maker selected chestnut wood for the construction of the new dial as this is a very stable, long-lasting wood having excellent weathering characteristics which would suit the location of the dial in the exposed location on the church tower at Nazeing. Three pieces of the wood were used, being tongue-jointed and glued vertically, similar to the construction of the leaves of a dining-room table. A copy of the plan was pasted to the dial plate to allow the maker to work on the design on the wood with a routing

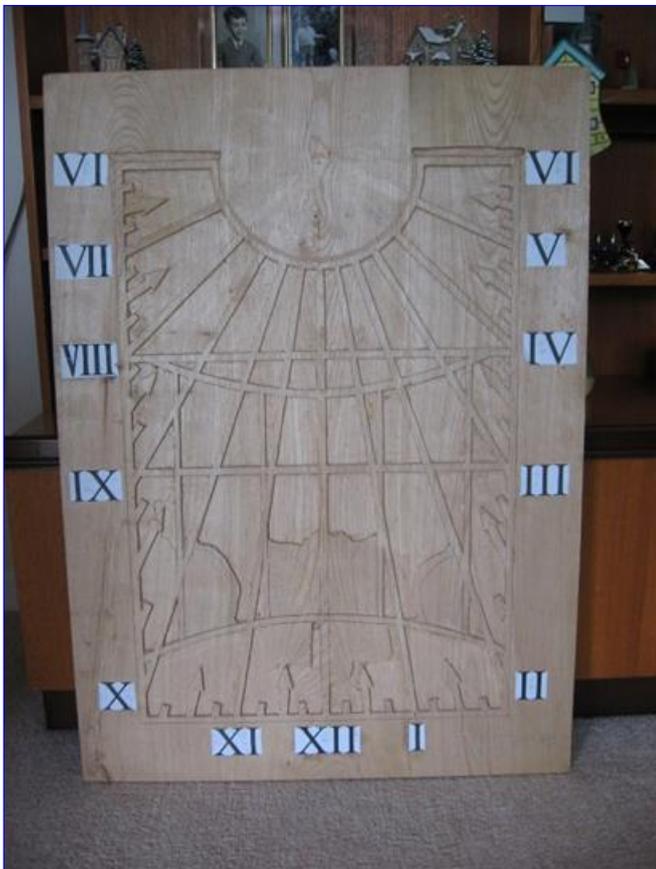
Fig. 8. The new dial with some areas still to be removed by the router.

Figs 8 and 9 show the work in progress, and the maker Barrie Winter with the old and new dials.

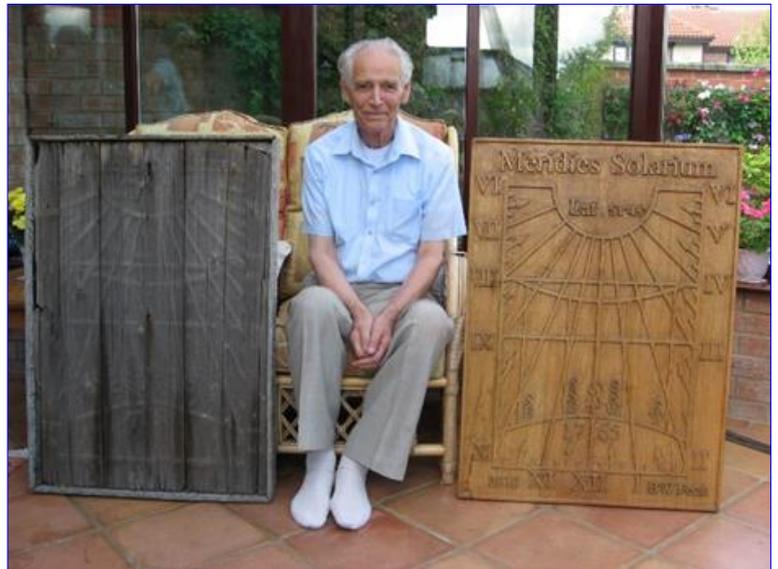
Fig. 9. Barrie Winter with his newly-completed dial and the original.

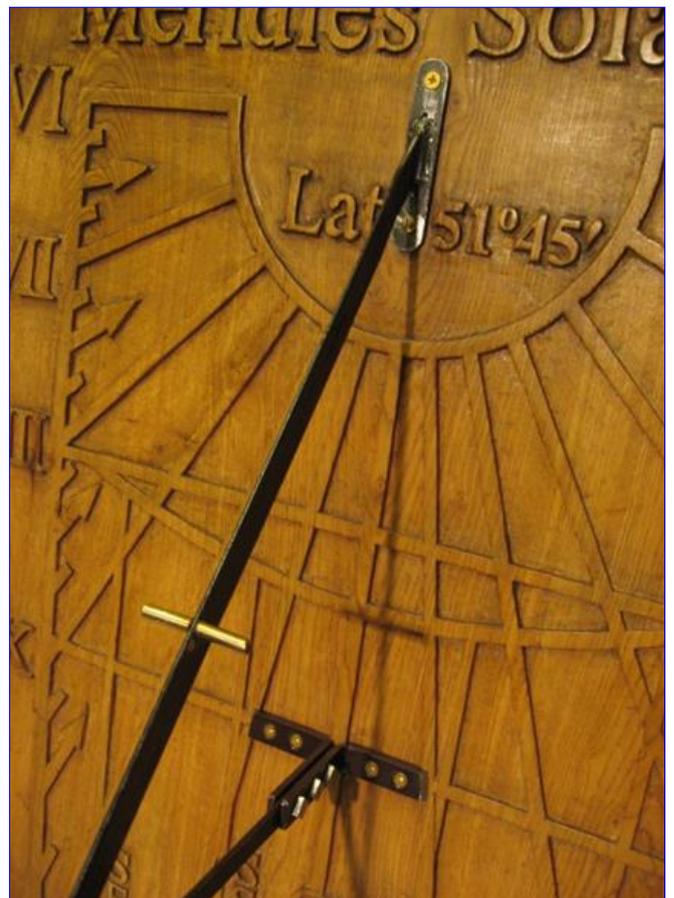
Fig. 10. Close-up of the new dial, with linseed oil applied and showing the gnomon fixing and the brass nodus.

Following construction, a number of coats of linseed oil were applied to the dial to assist with its preservation. The linseed oil would allow the wood to 'breathe' but not seal the surface to trap in moisture and hasten any rotting, which a covering of paint or varnish might have caused.

A nodus for the gnomon was also provided to enable the dial furniture to be fully utilized. This nodus, constructed in the form of a crossbar, was formed from the 'earth pins' of two redundant '3 pin, 5 amp' electric mains plugs. Both pins were tapped to enable a short length of threaded stud-
ding to join the two together through a newly-drilled hole at the correct position on the style edge of the gnomon.

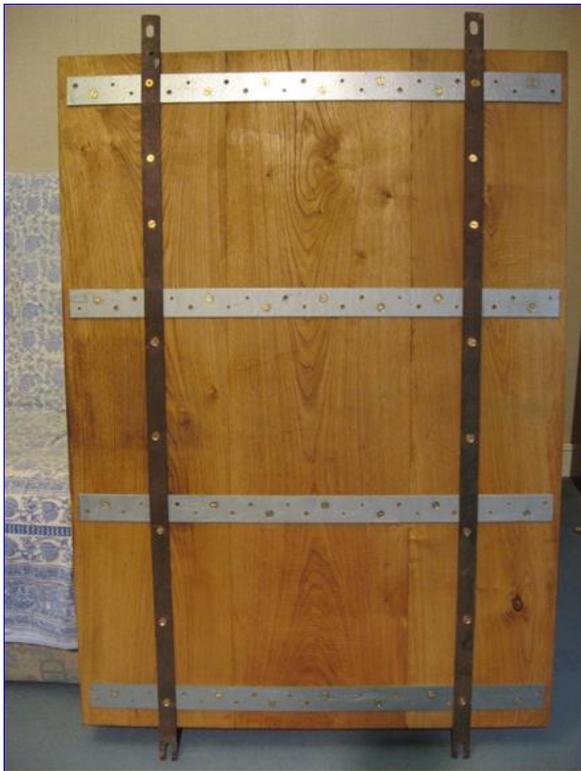
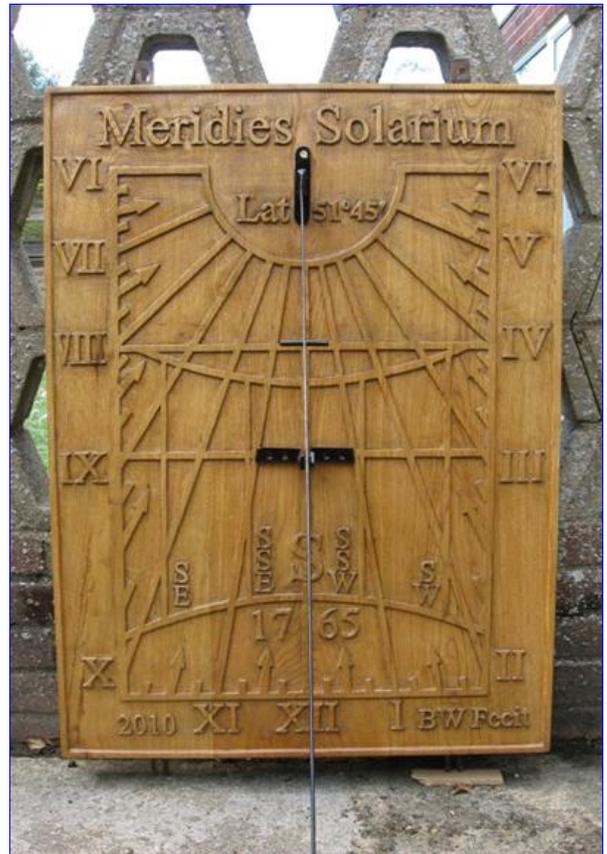
Figs 11 & 12.
Back and
front of the
finished dial.

The two original fixing straps were fixed to the rear of the dial with brass woodscrews, and additional galvanised metal strips were fitted horizontally to provide further reinforcing for the woodwork of the dial.

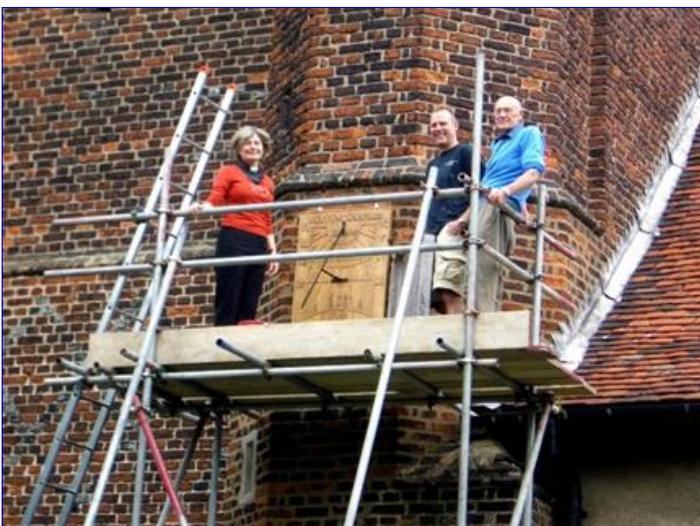
Fig. 13. The newly-installed dial.

In August 2010 scaffolding was re-provided to enable the new dial to be installed on the church tower. Installation of the new sundial by Bryn Pateman went fully to plan, with it subsequently being blessed by the church vicar, the Rev. Catherine Pennington. The whole operation was also overseen to the satisfaction of the benefactor.
